PHOTOGRAPHIC SURVEY OF THE LDEF MISSION

NASA Special Publication 531

Robert L. O'Neal

National Aeronautics and
Space Administration

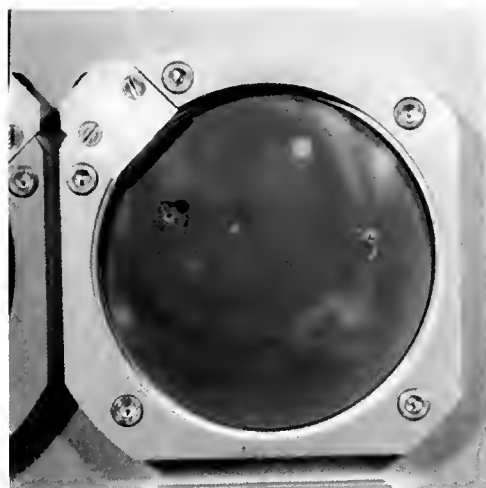
Figure 335 (Postflight). This close-up photograph is of a sensor and shows an impact crater. The sensor is located at the lower left corner of the solar cell baseplate. Other areas on the sensor also indicate impacts.

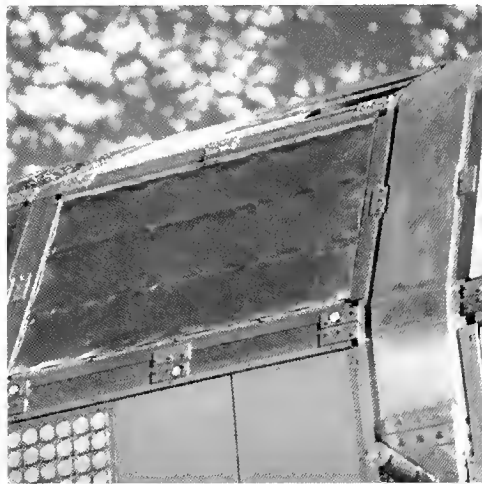
Figure 336 (In Flight). The thermal cover is without physical damage and is taut. The blue appearance of the thermal cover in this photograph is due to lighting conditions and not a change in the material optical properties. The oblong indentations in the thermal cover surface are areas where Velcro attachment pads are bonded to the back of the cover. The surface of the thermal cover appears to have small light blue circular discolorations of various sizes that appear to be impacts. The white irregular shapes in the photograph are light reflections from the edges of indentations in the cover surface. The scalloped edge along the left side of the thermal cover occurs between attachment pads. The ground strap is in place with no visible damage, but it also appears to be a deeper copper color than in the prelaunch photograph.

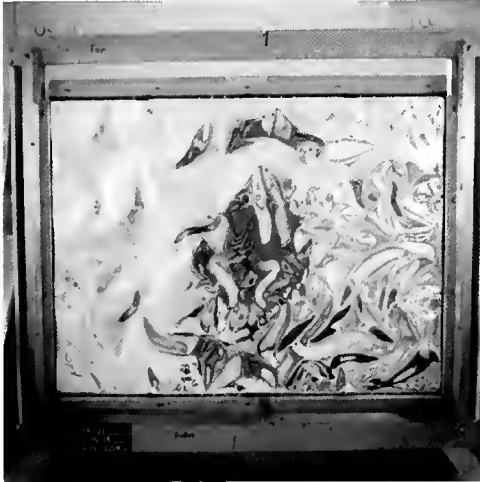
Figure 337
Photo No.: KSC-390C-1472.02
Dup. Neg.: L91-10248
LISAR No.: EL-1994-00207
Photo Credit: KSC
Photo Date: 2/26/90
Location: KSC SAEF II
Subject: Postflight Survey of Tray D7

Figure 337 (Postflight). The surface of the thermal cover appears specular with green and white discolorations from photographic lights and reflections of the surrounding area. The black or brown dots are impacts or penetrations. The cover is not as taut as in the in-flight photograph and locations of the Velcro attachment pads are not as prominent. The ground strap has no apparent physical damage, but it is a darker copper color than in the prelaunch photograph.

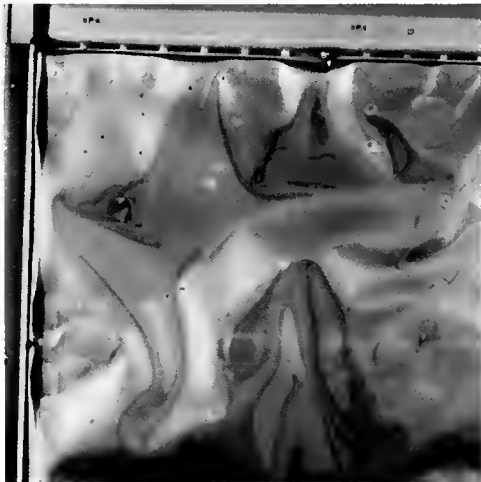
Figure 338
Photo No.: KSC-390C-1472.09
Dup. Neg. No.: L91-10255
LISAR No.: EL-1994-00194
Photo Credit: KSC
Photo Date: 2/26/90
Location: KSC SAEF II
Subject: Postflight Detail of Upper Left of Tray D7

Figure 338 (Postflight). This photograph is of the upper left one-sixth of the tray. The thermal cover appears specular with some small discolored impacts or penetrations. The reflective properties of the uneven surface of the cover result in various light and color patterns. The locations of the Velcro attachment pads are obvious.

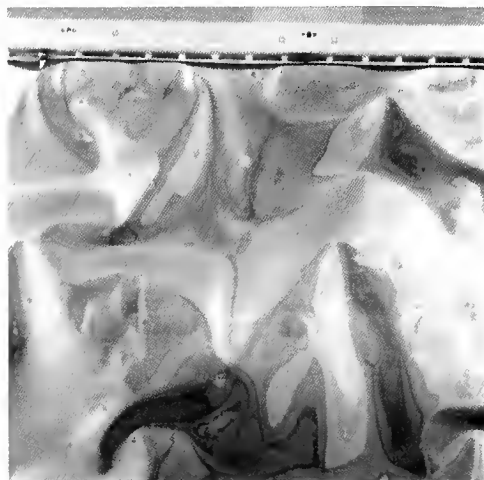
Figure 339 (Postflight). This photograph is of the upper center one-sixth of the tray. The thermal cover appears specular with some small discolored impacts or penetrations. The reflective properties of the uneven surface of the cover result in various light and color patterns. The locations of the Velcro attachment pads are obvious.

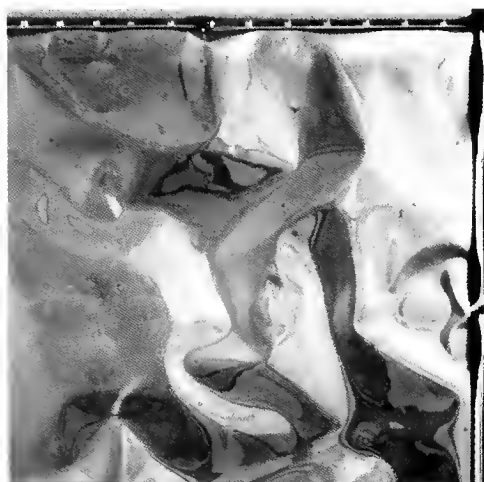
Figure 340 (Postflight). This photograph is of the upper right one-sixth of the tray. The thermal cover appears specular with some small discolored impacts or penetrations. The reflective properties of the uneven surface of the cover result in various light and color patterns. The locations of the Velcro attachment pads are obvious.

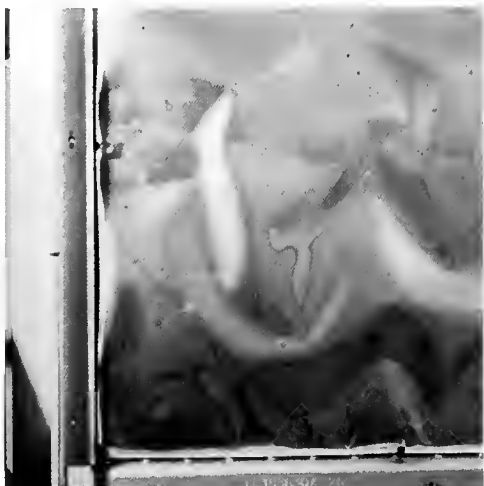
Figure 341
Photo No.: KSC-390C-1473.04
Dup. Neg. No.: L91-10262
LISAR No.: EL-1994-00208
Photo Credit: KSC
Photo Date: 2/26/90
Location: KSC SAEF II
Subject: Postflight Detail of Lower Left of Tray D7

Figure 341 (Postflight). This photograph is of the lower left one-sixth of the tray. The thermal cover appears specular with some small discolored impacts or penetrations. The reflective properties of the uneven surface of the cover result in various light and color patterns. The locations of the Velcro attachment pads are obvious.

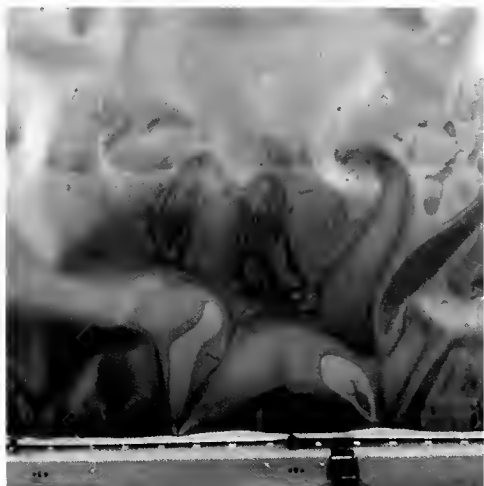
Figure 342
Photo No.: KSC-390C-1473.05
Dup. Neg. No.: L91-10263
LISAR No.: EL-1994-00209
Photo Credit: KSC
Photo Date: 2/26/90
Location: KSC SAEF II
Subject: Postflight Detail of Lower Center of
Tray D7

Figure 342 (Postflight). This photograph is of the lower center one-sixth of the tray. The thermal cover appears specular with some small discolored impacts or penetrations. The reflective properties of the uneven surface of the cover result in various light and color patterns. The locations of the Velcro attachment pads are obvious.

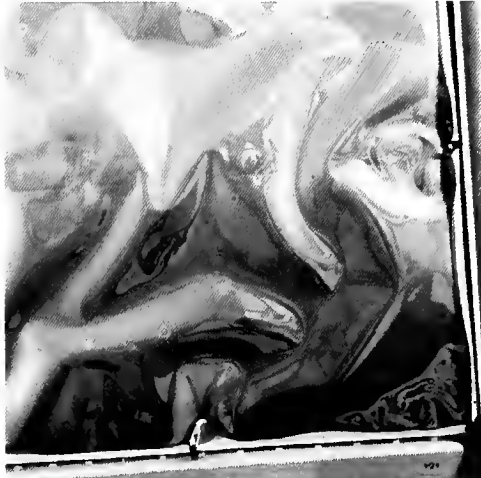
Figure 343 (Postflight). This photograph is of the lower right one-sixth of the tray. The thermal cover appears specular with some small discolored impacts or penetrations. The reflective properties of the uneven surface of the cover result in various light and color patterns. The locations of the Velcro attachment pads are obvious.

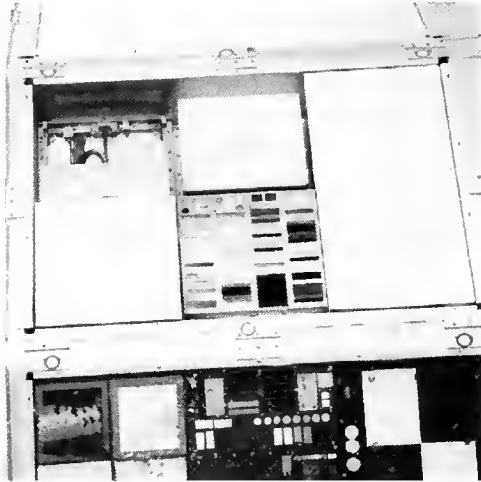
Figure 345
Photo No.: S32-76-013
Dup. Neg. No.: L90-10377
LISAR No.: EL-1994-00662
Photo Credit: JSC
Photo Date: 1/12/90
Location: In Flight
Subject: In-Flight Survey of Tray D8

Figure 345 (In Flight). The experiment hardware appears intact. The EPDS cover located in the right one-third of the tray has no apparent change in color, but the SCU cover located in the upper center one-sixth of the tray has a brownish tint with a darker tan strip along the lower line of screws. Colors of the composite material samples are bright and clear. Some material samples appear to be blue in this photograph, but they are not in prelaunch or post-flight photographs.

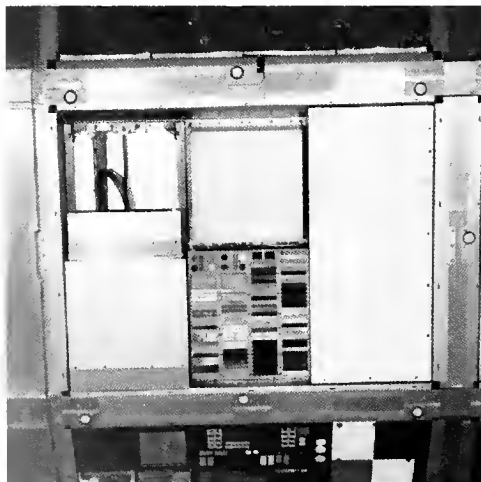
Figure 346
Photo No.: KSC-390C-1031.09
Dup. Neg. No.: L90-13419
LISAR No.: EL-1994-00145
Photo Credit: KSC
Photo Date: 2/9/90
Location: KSC SAEF II
Subject: Postflight Survey of Tray D8

Figure 346 (Postflight). There seems to be no change from the in-flight appearance. All test specimens and hardware are intact. The EPDS cover, which was painted white, shows no apparent change in color, but the white paint on the SCU cover has a slight brownish tint. Some composite material samples are dull, some are discolored, and some are a different color from the preflight photograph. The bright square discolorations on the upper corners of the thermal cover are pads of tape that were used to cover sharp corners that were exposed. The pads were not in place in the prelaunch photograph.

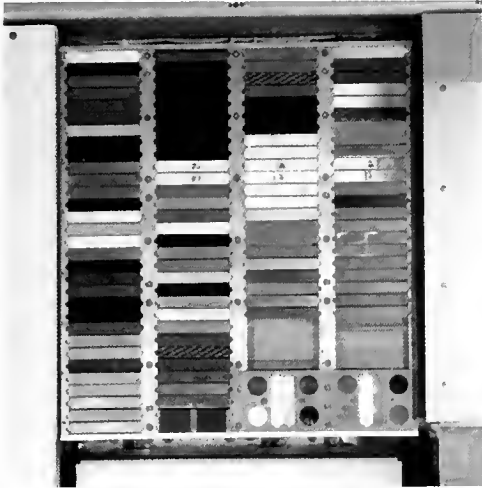
Figure 347
Photo No. KSC-390C-1534.12
Dup. Neg. No.: L91-10309
LISAR No.: EL-1994-00650
Photo Credit: KSC
Photo Date: 2/27/90
Location: KSC SAEF II
Subject: Postflight Detail of Lower Center of
Tray D8

Figure 347 (Postflight). This photograph is of the lower center one-sixth of the tray. Many of the test samples have changed color and have degraded finishes. The test specimen mounting hardware has numerous brown discolorations.

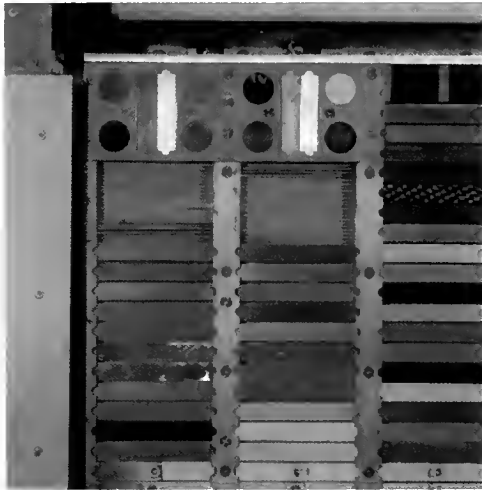
Figure 348
Photo No. KSC-390C-1535.02
Dup. Neg. No.: L91-10311
LISAR No.: EL-1994-00651
Photo Credit: KSC
Photo Date: 2/27/90
Location: KSC SAEF II
Subject: Postflight Detail of Upper Left of Lower
Center of Tray D8

Figure 348 (Postflight). This close-up photograph is of the upper left of the lower center one-sixth of the tray. Many of the test samples have changed color and have degraded finishes. The test specimen mounting hardware has numerous brown discolorations.

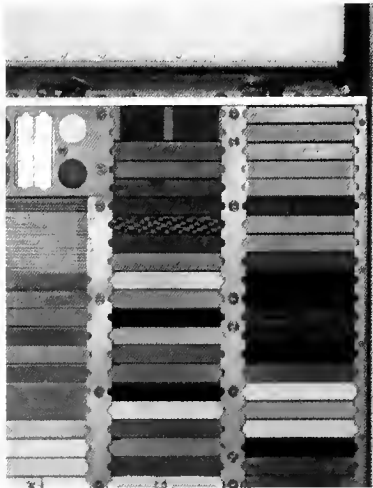
Figure 349 (Postflight). This close-up photograph is of the upper right of the lower center one-sixth of the tray. Many test samples have changed color and have degraded finishes. The test specimen mounting hardware has numerous brown discolorations.

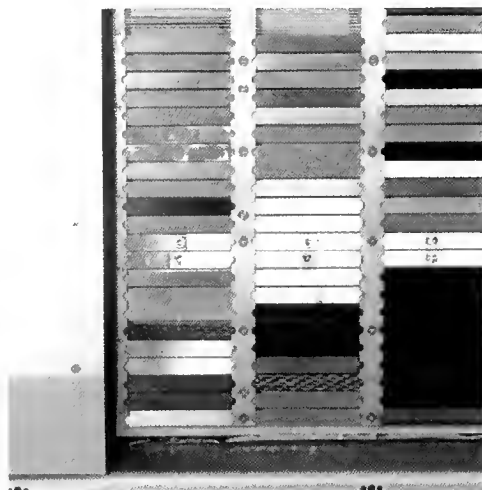
Figure 350 (Postflight). This close-up photograph is of the lower left of the lower center one-sixth of the tray. Many test samples have changed color and have degraded finishes. The test specimen mounting hardware has numerous brown discolorations.

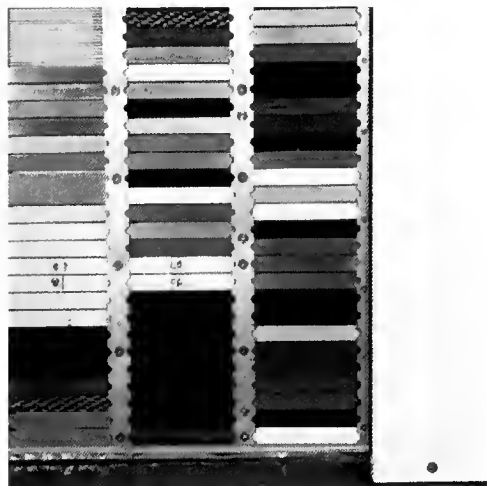
Figure 351 (Postflight). This close-up photograph is of the lower right of the lower center one-sixth of the tray. Many samples have changed color and have degraded finishes. The test specimen mounting hardware has numerous brown discolorations.

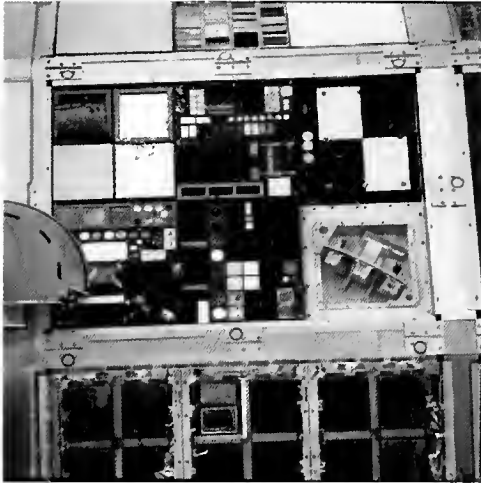
Figure 353
Photo No.: S32-78-093
Dup. Neg. No.: L90-10450
LISAR No.: EL-1994-00124
Photo Credit: JSC
Photo Date: 1/12/90
Location: In Flight
Subject: In-Flight Survey of Tray D9

Figure 353 (In Flight). The experiments located in the upper left and upper center sections are heavily coated with debris particles from other degraded experiments. Experiments in three of the five sections appear to have survived the mission with only minor physical damage. Experiments in the other two sections have sustained damage to thin metallized and coated polymer samples.

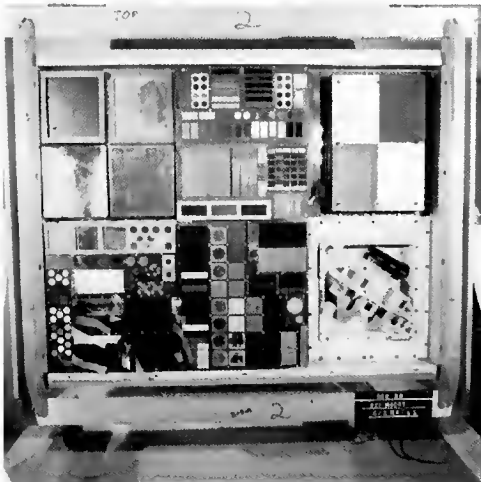
Figure 354
Photo No.: KSC-390C-1529.03
Dup. Neg. No.: L91-10336
LISAR No.: EL-1994-00211
Photo Credit: KSC
Photo Date: 2/27/90
Location: KSC SAEF II
Subject: Postflight Survey of Tray D9

Figure 354 (Postflight). Experiments in three of the five sections appear to have survived the mission with minor physical damage. The experiments located in the upper left and upper center sections do not have the loose debris particles from the degradation of other experiments that were visible in the in-flight photograph. Experiments in the other two sections have sustained damage to thin metallized and coated polymer samples.

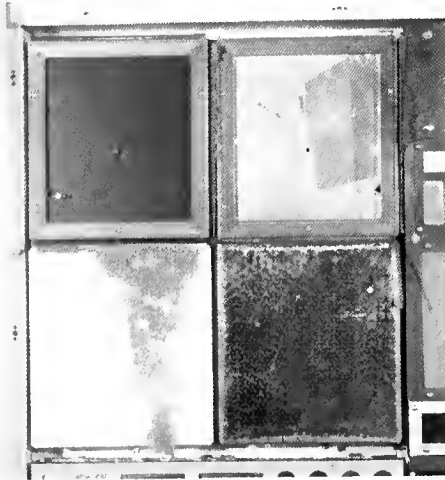
Figure 355 (Postflight). This photograph is of the upper left one-sixth of the tray. The thin film on the lower left corner is damaged. A shadow is visible on the upper right quadrant. A number of small impacts are visible.

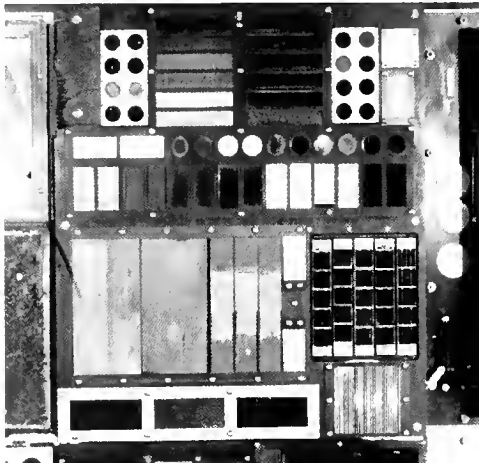
Figure 356 (Postflight). This photograph is of the upper center one-sixth of the tray. The test samples appear intact, but many are discolored.

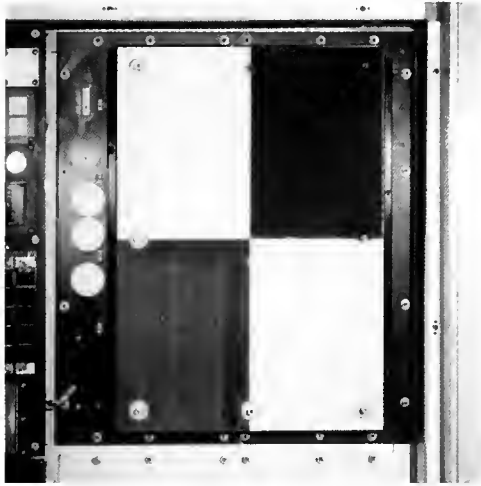
Figure 357 (Postflight). This photograph is of the upper right one-sixth of the tray. The test samples appear intact, but there seems to be some discoloration near the upper left corner of the baseplate.

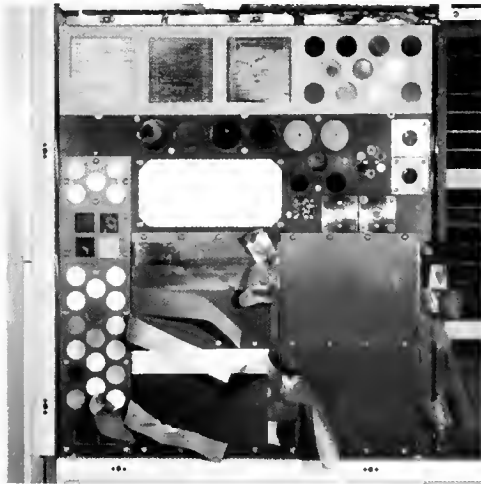
Figure 358 (Postflight). This photograph is of the lower left one-sixth of the tray. Many of the thin-film test specimens have broken and are attached by one end. Other test specimens appear intact, but some are discolored.

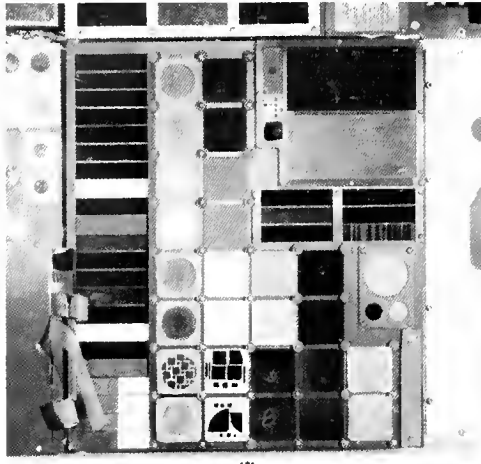
Figure 359 (Postflight). This photograph is of the lower center one-sixth of the tray. Loose ends of thin-film test samples are visible at the lower left corner. Other test specimens appear intact, but have some discoloration.

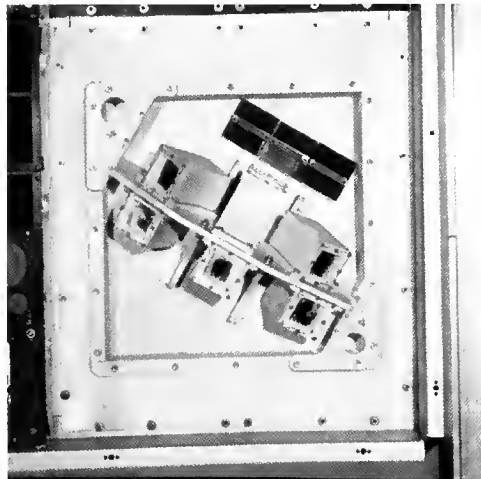
Figure 360 (Postflight). This photograph is of the lower right one-sixth of the tray. This experiment appears intact with some brown discoloration.

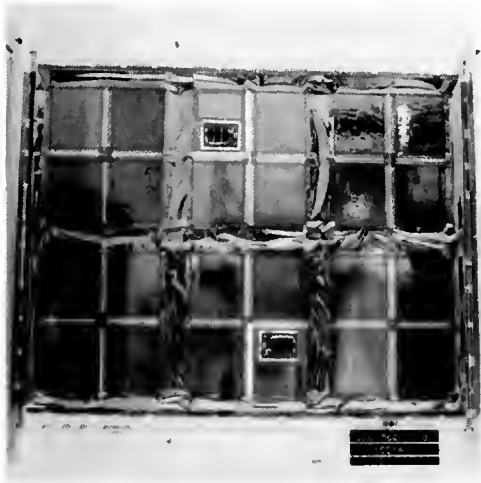
Figure 361 (Preflight). The experiment hardware is identical to that in tray B4 and shown in figure 158. Experiment AO054 consisted of two identical sets of hardware: one was mounted in tray B4 and the other was mounted in tray D10. Each set of hardware, which was self-contained within the experiment tray, consisted of six fiberglass-reinforced epoxy modules that carried charged dielectric samples on top and power supplies and electronics underneath. Four dielectric samples of Kapton film with vapor-deposited aluminum on one side (VDA-Kapton film) were bonded to each of the fiberglass modules with a silver-filled conductive epoxy adhesive. The spaces between the modules and between the modules and the tray flanges were covered by strips of VDA-Kapton film attached with acrylic transfer adhesive and Kapton tape. In this photograph, reflections in the mirrorlike surfaces are visible. Each experiment tray also contained two solar cell modules.

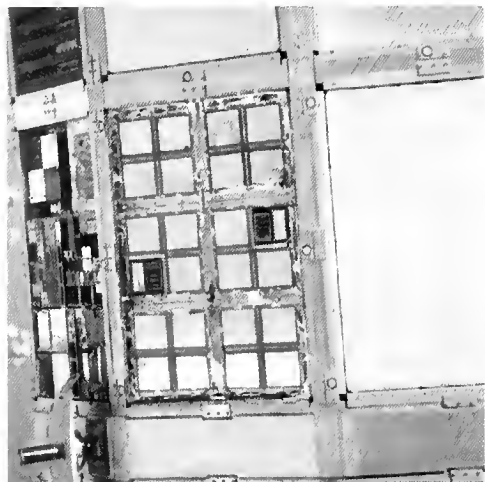
Figure 362 (In Flight). The experiment is severely degraded. The most noticeable change is that the VDA-Kapton strips used to cover spaces between the modules have degraded substantially and only fragments of the layer of vapor-deposited aluminum remain attached along the edges. Other areas also show major degradation.

Figure 362
Photo No.: S32-78-062
Dup. Neg. No.: L90-10439
LISAR No.: EL-1994-00014
Photo Credit: JSC
Photo Date: 1/12/90
Location: In Flight
Subject: In-Flight Survey of Tray D10

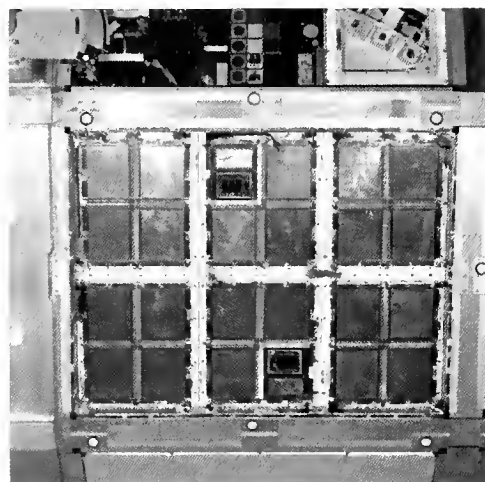
Figure 363 (Postflight). The experiment is severely degraded by impingement of atomic oxygen during exposure to the space environment. Most of the polyimide material making up the dielectric samples was completely eroded, thus leaving only the 2000 A to 3000 A layer of VDA bonded to the module.

Figure 363
Photo No.: KSC-390C-1029.07
Dup. Neg. No.: L90-13393
LISAR No.: EL-1994-00142
Photo Credit: KSC
Photo Date: 2/9/90
Location: KSC SAEF II
Subject: Postflight Survey of Tray D10

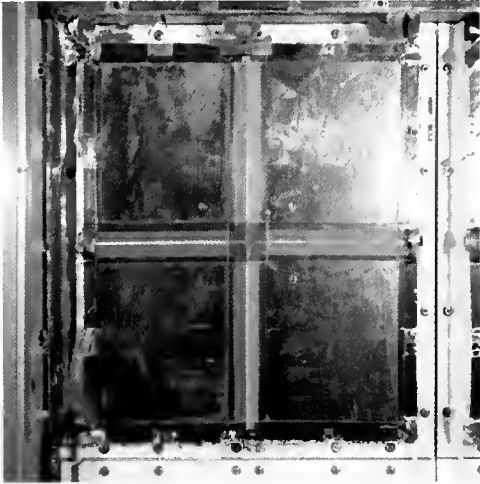
Figure 364 (Postflight). This photograph is of the upper left one-sixth of the tray. The polyimide material making up the dielectric samples was completely eroded, thus leaving only the 2000 A to 3000 A layer of VDA bonded to the module. The edges of the dielectric surface that survived were covered by Kapton tape with a silicone adhesive. The Kapton backing eroded, thus leaving the silicone adhesive that protected the Kapton surface beneath. The VDA-Kapton strips used to cover spaces between the modules were degraded substantially and only fragments of the extremely fragile VDA layer remain.

Figure 364
Photo No.: KSC-390C-1770.05
Dup. Neg. No.: L91-9107
LISAR No.: EL-1994-00222
Photo Credit: KSC
Photo Date: 3/9/90
Location: KSC SAEF II
Subject: Postflight Detail of Upper Left of Tray D10

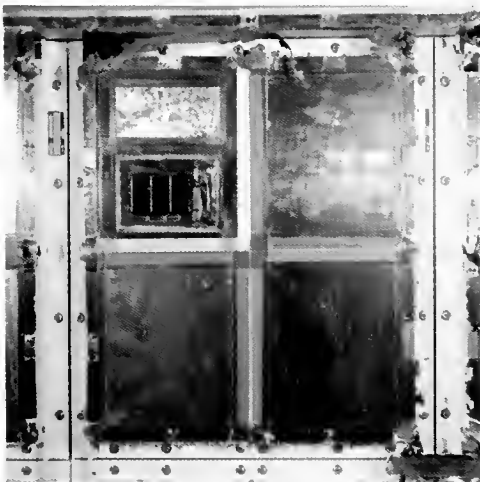
Figure 365 (Postflight). This photograph is of the upper center one-sixth of the tray. The polyimide material making up the dielectric samples was completely eroded, thus leaving only the 2000 A to 3000 A layer of VDA bonded to the module. The edges of the dielectric surface that survived were covered by Kapton tape with a silicone adhesive. The Kapton backing eroded, thus leaving the silicone adhesive that protected the Kapton surface beneath. The VDA-Kapton strips used to cover spaces between the modules were degraded substantially and only fragments of the extremely fragile VDA layer remain.

Figure 365
Photo No.: KSC-390C-1770.06
Dup. Neg. No.: L91-9108
LISAR No.: EL-1994-00223
Photo Credit: KSC
Photo Date: 3/9/90
Location: KSC SAEF II
Subject: Postflight Detail of Upper Center of
Tray D10

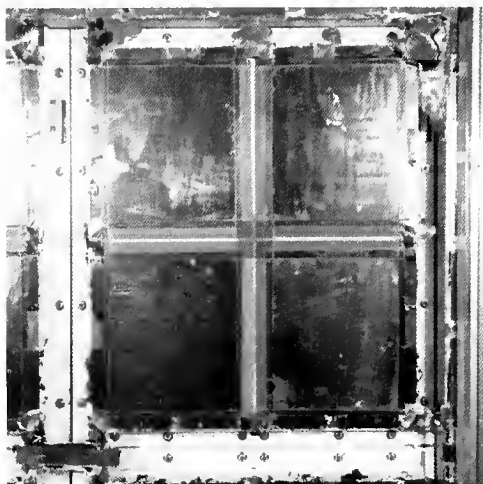
Figure 366 (Postflight). This photograph is of the upper right one-sixth of the tray. The polyimide material making up the dielectric samples was completely eroded, thus leaving only the 2000 A to 3000 A layer of VDA bonded to the module. The edges of the dielectric surface that survived were covered by Kapton tape with a silicone adhesive. The Kapton backing eroded, thus leaving the silicone adhesive that protected the Kapton surface beneath. The VDA-Kapton strips used to cover spaces between the modules were degraded substantially and only fragments of the extremely fragile VDA layer remain.

Figure 366
Photo No.: KSC-390C-1770.07
Dup. Neg. No.: L91-9109
LISAR No.: EL-1994-00224
Photo Credit: KSC
Photo Date: 3/9/90
Location: KSC SAEF II
Subject: Postflight Detail of Upper Right of
Tray D10

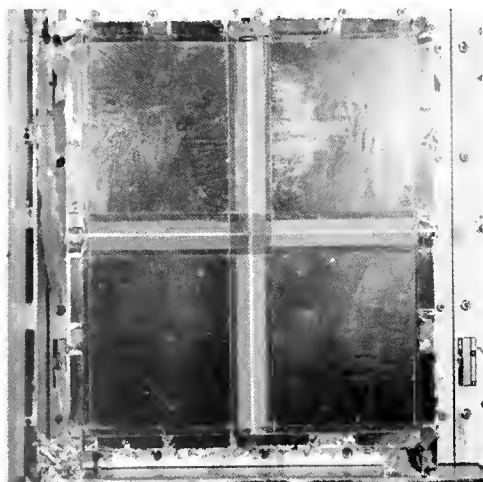
Figure 367 (Postflight). This photograph is of the lower left one-sixth of the tray. The polyimide material making up the dielectric samples was completely eroded, thus leaving only the 2000 A to 3000 A layer of VDA bonded to the module. The edges of the dielectric surface that survived were covered by Kapton tape with a silicone adhesive. The Kapton backing eroded, thus leaving the silicone adhesive that protected the Kapton surface beneath. The VDA-Kapton strips used to cover spaces between the modules were degraded substantially and only fragments of the extremely fragile VDA layer remain.

Figure 367
Photo No.: KSC-390C-1770.08
Dup. Neg. No.: L91-9110
LISAR No.: EL-1994-00225
Photo Credit: KSC
Photo Date: 3/9/90
Location: KSC SAEF II
Subject: Postflight Detail of Lower Left of Tray D10

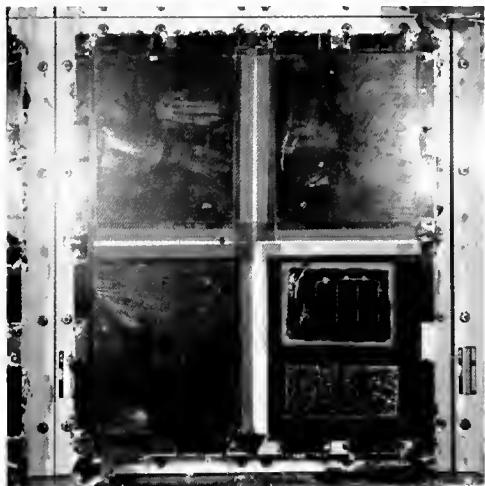
Figure 368 (Postflight). This photograph is of the lower center one-sixth of the tray. The polyimide material making up the dielectric samples was completely eroded, thus leaving only the 2000 A to 3000 A layer of VDA bonded to the module. The edges of the dielectric surface that survived were covered by Kapton tape with a silicone adhesive. The Kapton backing eroded, thus leaving the silicone adhesive that protected the Kapton surface beneath. The VDA-Kapton strips used to cover spaces between the modules were degraded substantially and only fragments of the extremely fragile VDA layer remain.

Figure 368
Photo No.: KSC-390C-1770.09
Dup. Neg. No.: L91-9111
LISAR No.: EL-1994-00226
Photo Credit: KSC
Photo Date: 3/9/90
Location: KSC SAEF II
Subject: Postflight Detail of Lower Center of
Tray D10

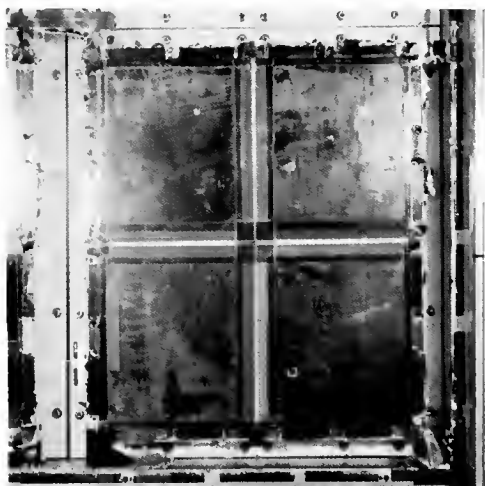
Figure 369 (Postflight). This photograph is of the lower right one-sixth of the tray. The polyimide material making up the dielectric samples was completely eroded, thus leaving only the 2000 A to 3000 A layer of VDA bonded to the module. The edges of the dielectric surface that survived were covered by Kapton tape with a silicone adhesive. The Kapton backing eroded, thus leaving the silicone adhesive that protected the Kapton surface beneath. The VDA-Kapton strips used to cover spaces between the modules were degraded substantially and only fragments of the extremely fragile VDA layer remain.

Figure 369
Photo No.: KSC-390C-1770.10
Dup. Neg. No.: L91-9112
LISAR No.: EL-1994-00227
Photo Credit: KSC
Photo Date: 3/9/90
Location: KSC SAEF II
Subject: Postflight Detail of Lower Right of
Tray D10

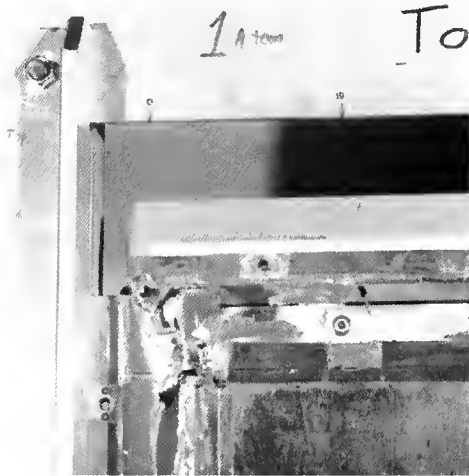
Figure 370 (Postflight). This photograph is of the upper left corner of the tray. The VDA-Kapton strips used to cover spaces between the modules have degraded substantially and only fragments of the extremely fragile VDA layer remain.

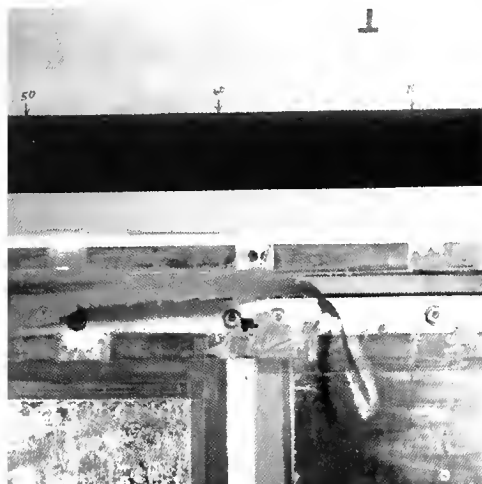
Figure 371 (Postflight). This photograph is of the upper center edge of the tray. The VDA-Kapton strips used to cover spaces between the modules have degraded substantially and only fragments of the extremely fragile VDA layer remain.

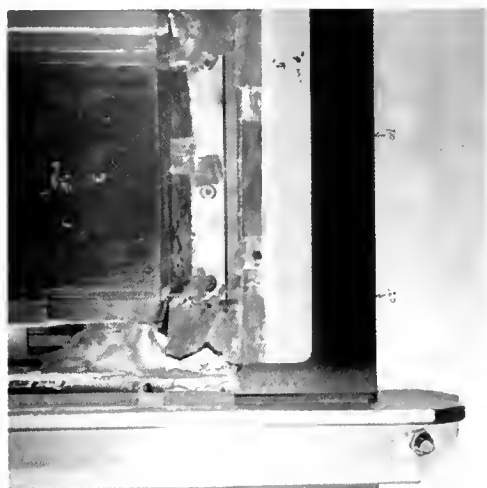
Figure 372 (Postflight). This photograph is of the lower right corner of the tray. The VDA-Kapton strips used to cover spaces between the modules have degraded substantially and only fragments of the extremely fragile VDA layer remain.

Figure 372
Photo No.: KSC-390C-1771.02
Dup. Neg. No.: L91-9116
LISAR No.: EL-1994-00394
Photo Credit: KSC
Photo Date: 3/9/90
Location: KSC SAEF II
Subject: Postflight Detail of Lower Right Corner of
Tray D10

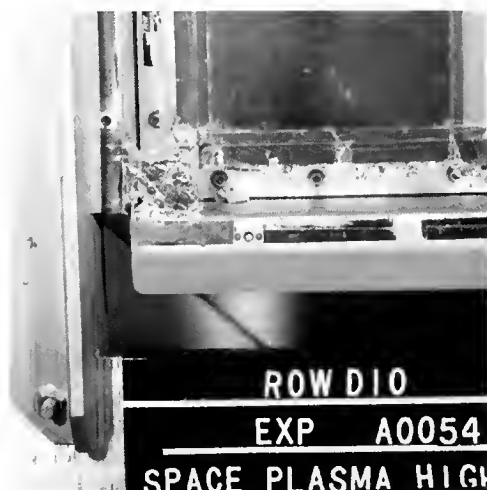
Figure 373 (Postflight). This photograph is of the lower left corner of the tray. The VDA-Kapton strips used to cover spaces between the modules have degraded substantially and only fragments of the extremely fragile VDA layer remain.

Figure 373
Photo No.: KSC-390C-1771.03
Dup. Neg. No.: L91-9117
LISAR No.: EL-1994-00395
Photo Credit: KSC
Photo Date: 3/9/90
Location: KSC SAEF II
Subject: Postflight Detail of Lower Left Corner of
Tray D10

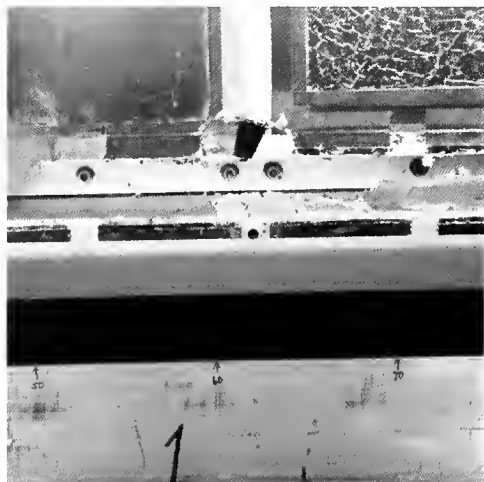
Figure 374 (Postflight). This photograph is of the lower center edge of the tray. The VDA-Kapton strips used to cover spaces between the modules have degraded substantially and only fragments of the extremely fragile VDA layer remain.

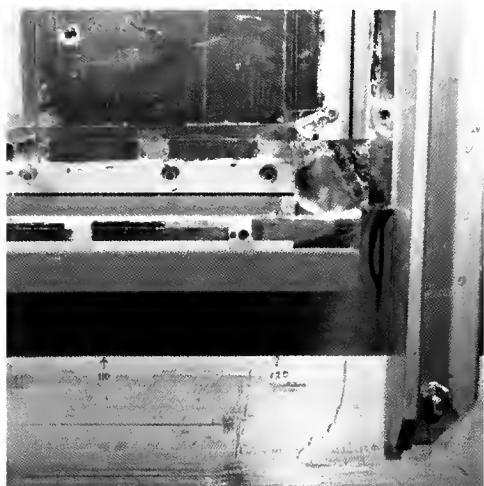
Figure 375 (Postflight). This photograph is of the lower right corner of the tray. The VDA-Kapton strips used to cover spaces between the modules have degraded substantially and only fragments of the extremely fragile VDA layer remain.

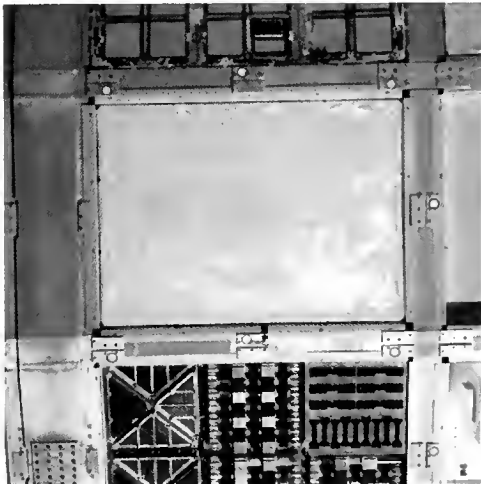
Figure 376 (In Flight). The thermal cover surface has changed from specular to opaque with numerous black dots and dimples of various sizes that indicate space debris impacts or penetrations. There is an area of reflected light in the lower right area. The cover is taut and the locations of Velcro attachment pads are prominent. The ground strap appears to have no visible damage, but it appears to be a deeper copper color.

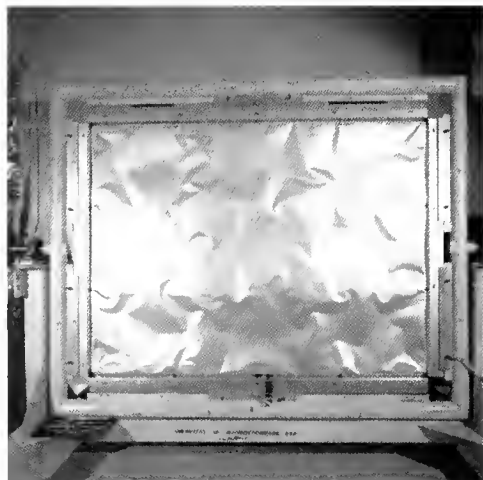
Figure 377 (Postflight). The thermal cover surface has changed from specular to opaque. Reflected light obscures some surface details. There are a number of small dark spots, which indicate impacts or penetrations. The cover is not as taut as in the in-flight photograph and locations of Velcro attachment pads are not as prominent. The ground strap appears to have no visible damage, but it appears to be a deeper copper color.

Figure 377
Photo No.: KSC-390C-1768.06
Dup. Neg. No.: L91-9382
LISAR No.: EL-1994-00277
Photo Credit: KSC
Photo Date: 3/9/90
Location: KSC SAEF II
Subject: Postflight Survey of Tray D11

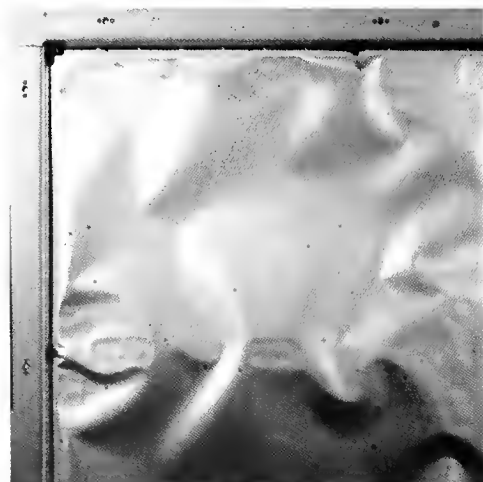
Figure 378 (Postflight). This photograph is of the upper left one-sixth of the tray. The thermal cover appears opaque, rather than specular as it was in preflight photographs. There are numerous discolored impacts or penetrations visible. The Velcro thermal cover attachment pads are evident.

Figure 378
Photo No.: KSC-390C-1768.07
Dup. Neg. No.: L91-9383
LISAR No.: EL-1994-00257
Photo Credit: KSC
Photo Date: 3/9/90
Location: KSC SAEF II
Subject: Postflight Detail of Upper Left of Tray D11

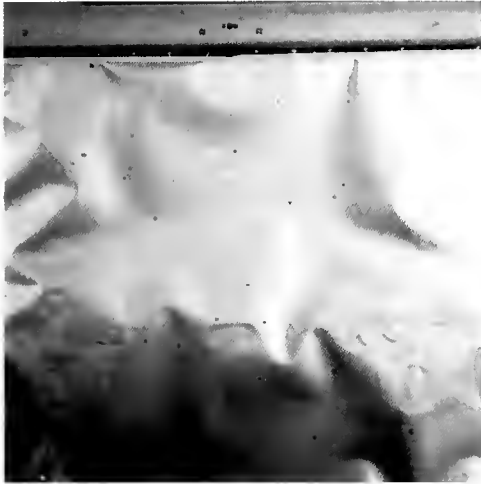
Figure 379 (Postflight). This photograph is of the upper center one-sixth of the tray. The thermal cover appears opaque, rather than specular as it was in preflight photographs. There are numerous discolored impacts or penetrations visible. The Velcro thermal cover attachment pads are evident.

Figure 379
Photo No.: KSC-390C-1768.08
Dup. Neg. No.: L91-9384
LISAR No.: EL-1994-00258
Photo Credit: KSC
Photo Date: 3/9/90
Location: KSC SAEF II
Subject: Postflight Detail of Upper Center of
Tray D11

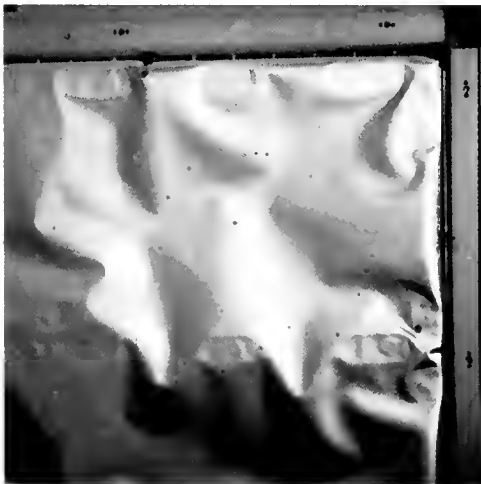
Figure 380 (Postflight). This photograph is of the upper right one-sixth of the tray. The thermal cover appears opaque, rather than specular as it was in preflight photographs. There are numerous discolored impacts or penetrations visible. The Velcro thermal cover attachment pads are evident.

Figure 380
Photo No.: KSC-390C-1768.09
Dup. Neg. No.: L91-9385
LISAR No.: EL-1994-00242
Photo Credit: KSC
Photo Date: 3/9/90
Location: KSC SAEF II
Subject: Postflight Detail of Upper Right of
Tray D11

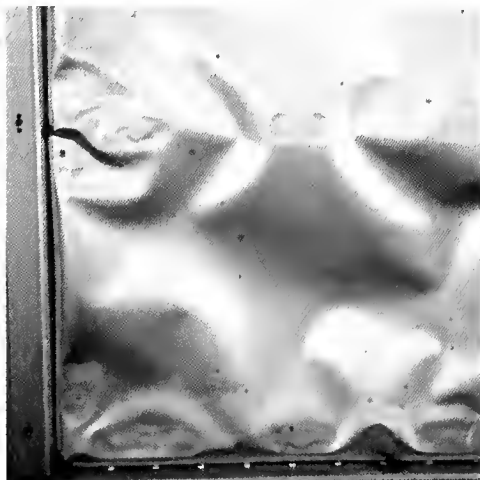
Figure 381 (Postflight). This photograph is of the lower left one-sixth of the tray. The thermal cover appears opaque, rather than specular as it was in preflight photographs. There are numerous discolored impacts or penetrations visible. The Velcro thermal cover attachment pads are evident.

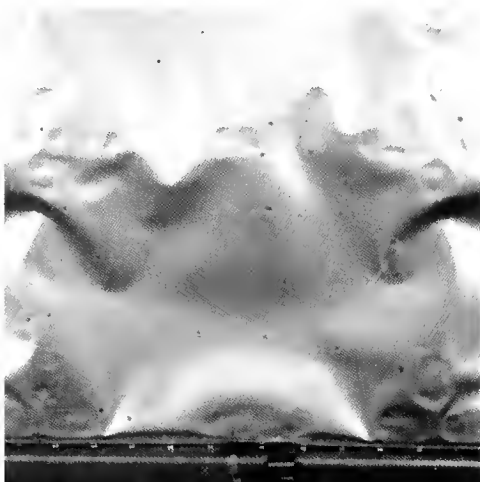
Figure 382 (Postflight). This photograph is of the lower center one-sixth of the tray. The thermal cover appears opaque, rather than specular as it was in preflight photographs. There are numerous discolored impacts or penetrations visible. The Velcro thermal cover attachment pads are evident.

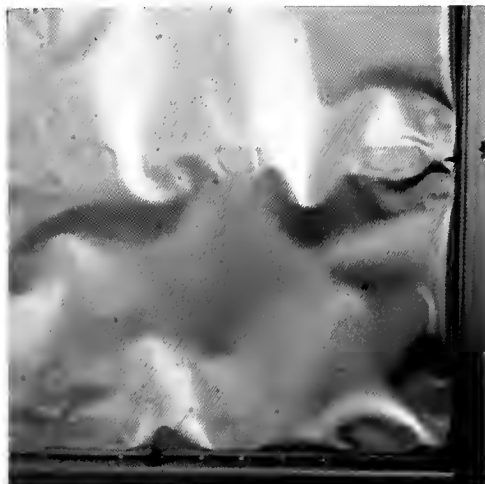
Figure 383 (Postflight). This photograph is of the lower right one-sixth of the tray. The thermal cover appears opaque, rather than specular as it was in preflight photographs. There are numerous discolored impacts or penetrations visible. The Velcro thermal cover attachment pads are evident.

Figure 383
Photo No.: KSC-390C-1768.12
Dup. Neg. No.: L91-9388
LISAR No.: EL-1994-00221
Photo Credit: KSC
Photo Date: 3/9/90
Location: KSC SAEF II
Subject: Postflight Detail of Lower Right of
Tray D11

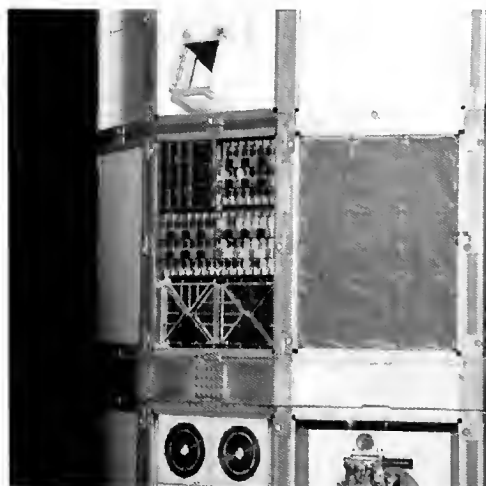
Figure 385 (In Flight). All experiment test specimens and hardware appear intact. Reflected sunlight caused uneven lighting of the frames of experiment AO023 and a white shape on the tray sidewall above the experiment detector stack. There is some change in the colors of the material of experiment AO180. Note the change in color of the tray clamp white dots across the photograph. The change from white to brown indicates the transition between leading and trailing sides.

Figure 385
Photo No.: S32-89-052
Dup. Neg. No.: L90-10502
LISAR No.: EL-1994-00137
Photo Credit: JSC
Photo Date: 1/12/90
Location: In Flight
Subject: In-Flight Survey of Tray D12

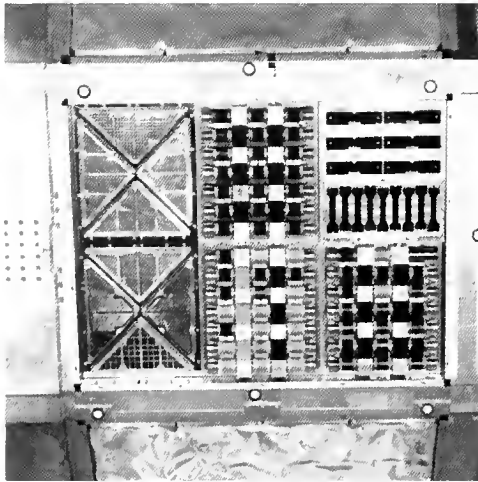
Figure 386
Photo No.: KSC-390C-1069.10
Dup. Neg. No.: L90-13490
LISAR No.: EL-1994-00203
Photo Credit: KSC
Photo Date: 2/8/90
Location: KSC SAEF II
Subject: Postflight Survey of Tray D5

Figure 386 (Postflight). All experiment hardware remains intact. No change from inflight appearance is apparent. There are light reflections on many sensor surfaces.

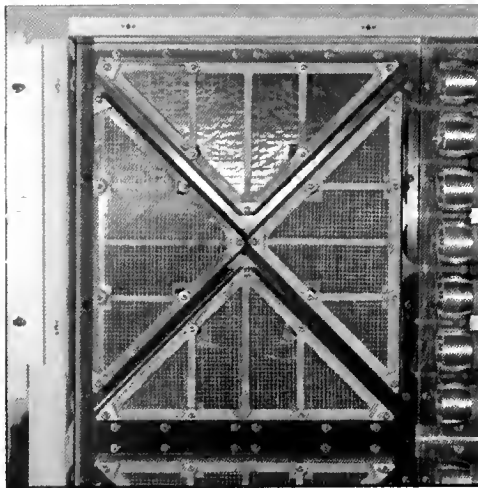
Figure 387
Photo No.: KSC-390C-2035.03
Dup. Neg. No.: L91-10379
LISAR No.: EL-1994-00456
Photo Credit: KSC
Photo Date: 3/16/90
Location: KSC SAEF II
Subject: Postflight Detail of Upper Left of Tray D12

Figure 387 (Postflight). This photograph is of the upper left one-sixth of the tray. The sensor foils in the triangular quadrants are intact and some light reflects on the foil surfaces. There is some discoloration on the mounting frames.

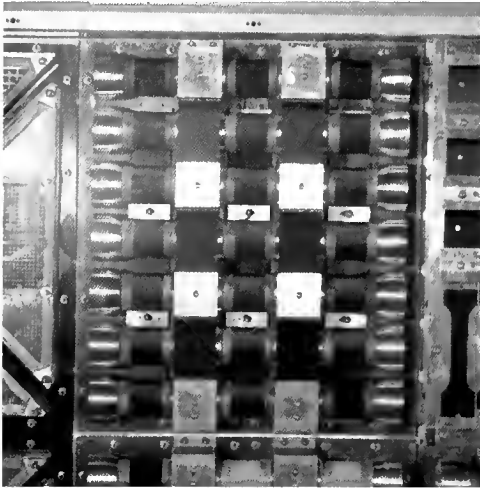
Figure 388
Photo No.: KSC-390C-2035.04
Dup. Neg. No.: L91-10380
LISAR No.: EL-1994-00457
Photo Credit: KSC
Photo Date: 3/16/90
Location: KSC SAEF II
Subject: Postflight Detail of Upper Center of
Tray D12

Figure 388 (Postflight). This photograph is of the upper center one-sixth of the tray. There is little change in the colors of the test specimens.

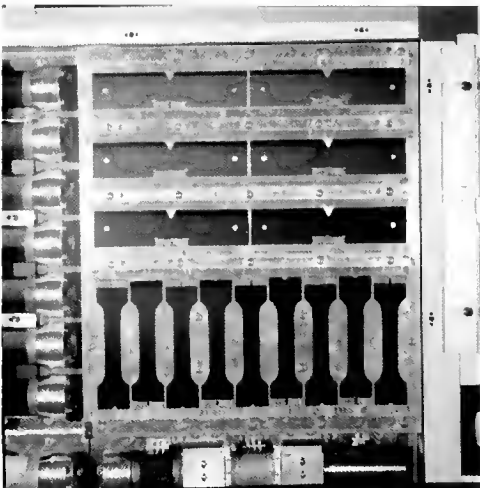
Figure 389
Photo No.: KSC-390C-2035.05
Dup. Neg. No.: L91-10381
LISAR No.: EL-1994-00458
Photo Credit: KSC
Photo Date: 3/16/90
Location: KSC SAEF II
Subject: Postflight Detail of Upper Right of
Tray D12

Figure 389 (Postflight). This photograph is of the upper right one-sixth of the tray. The test specimens are intact with no visible difference from preflight. The red passive temperature indicators remain bonded to the test specimens.

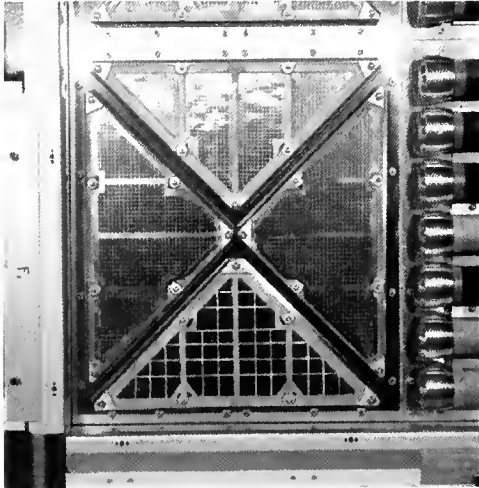
Figure 390 (Postflight). This photograph is of the lower left one-sixth of the tray. The sensor foils in the triangular quadrants are intact and some light reflects on the foils of the upper section. There is some discolorations along the foil and mounting frame line of the left and right quadrants.

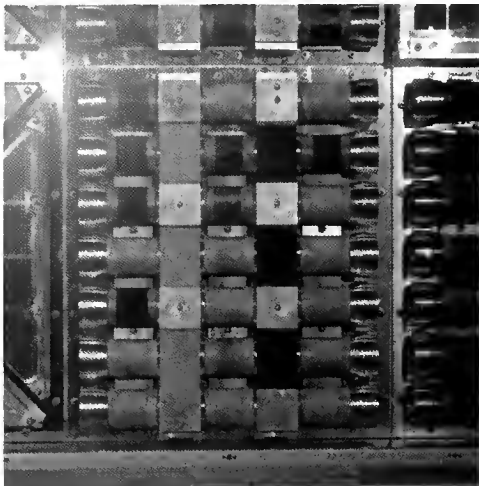
Figure 391 (Postflight). This photograph is of the lower center one-sixth of the tray. The test specimens are intact, but some are darker than in the preflight photograph.

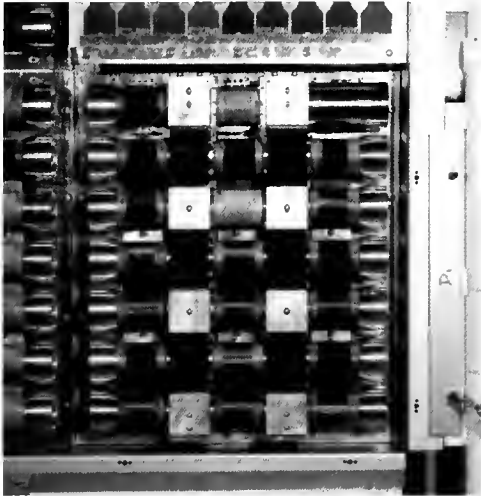
Figure 392 (Postflight). This photograph is of the lower right one-sixth of the tray. The test specimens are intact, but some are darker than in the preflight photograph.

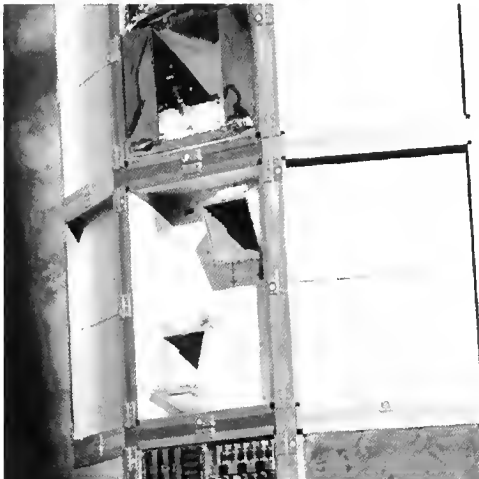
Figure 393 (In Flight). The pink and greenish-gray tints on the two debris panels are by-products of the chromic anodize coating process and are not attributed to contamination or exposure to the space environment. The light color band across the top of the panels is a reflection from the tray sidewall.

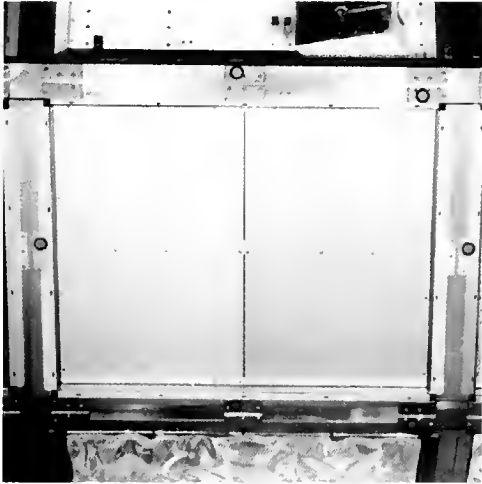
Figure 394
Photo No.: KSC-390C-1066.08
Dup. Neg. No.: L90-13477
LISAR No.: EL-1994-00187
Photo Credit: KSC
Photo Date: 2/8/90
Location: KSC SAEF II
Subject: Postflight Survey of Tray E1

Figure 394 (Postflight). The pink and greenish-gray tints on the two debris panels are by-products of the chromic anodize coating process and are not attributed to contamination or exposure to the space environment. The light band along the bottom of the panels is caused by light reflecting from the tray sidewalls.

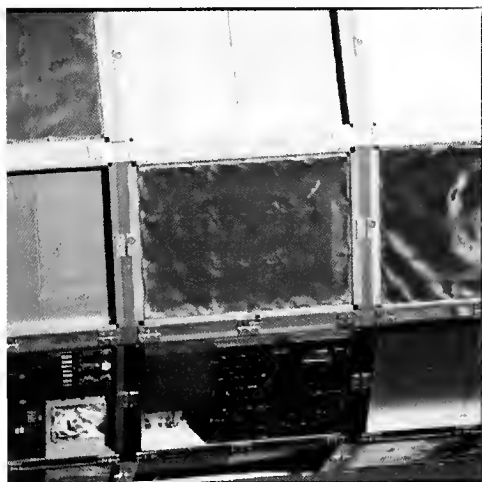
Figure 395 (In Flight). The thermal cover appears to be without visible damage, but it is more taut than in the prelaunch photograph. The Velcro attachment pads are evident. The grainy pattern in the surface finish, which is visible in the light reflection, was on the material prior to flight and is not from the space environment. The rippled effect around the cover edges occurs between the attachment pads.

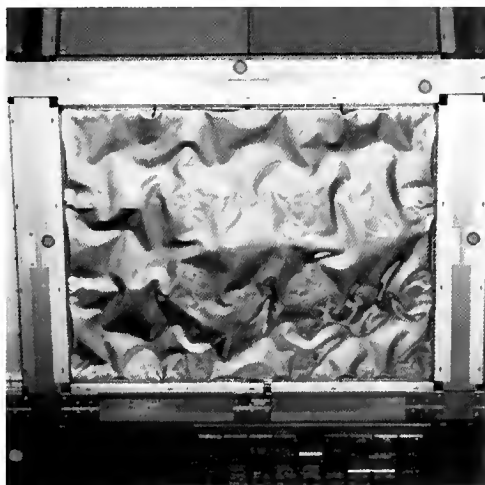
Figure 396
Photo No.: KSC-390C-1065.11
Dup. Neg.: L90-13468
LISAR No.: EL-1994-00385
Photo Credit: KSC
Photo Date: 2/8/90
Location: KSC SAEF II
Subject: Postflight Survey of Tray E2

Figure 396 (Postflight). The thermal cover appears to be specular with no apparent damage. It is less taut than in the in-flight photograph. The Velcro attachment pads are more visible than in the prelaunch photograph. The scallop effect around the cover edges occurs between the attachment pads and shows the upper edge of the support frame. The ground strap is in place with no visible damage, but it is a darker color.

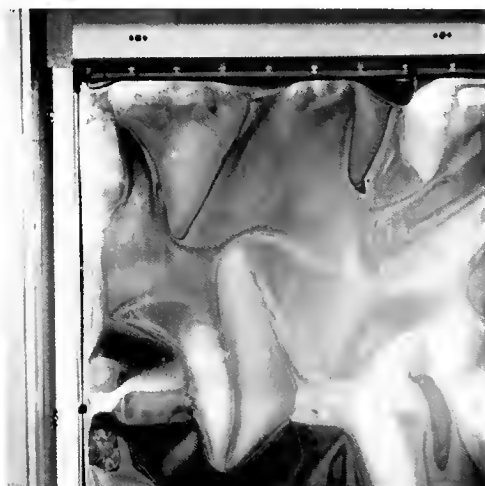
Figure 397
Photo No.: KSC-390C-2336.03
Dup. Neg. No.: L91-10423
LISAR No.: EL-1994-006026
Photo Credit: KSC
Photo Date: 3/27/90
Location: KSC SAEF II
Subject: Postflight Detail of Upper Left of Tray E2

Figure 397 (Postflight). This photograph is of the upper left one-sixth of the tray. The thermal cover appears specular with no apparent damage. The reflective properties of the uneven surface of the cover result in various light and color patterns. The locations of the Velcro attachment pads are visible.

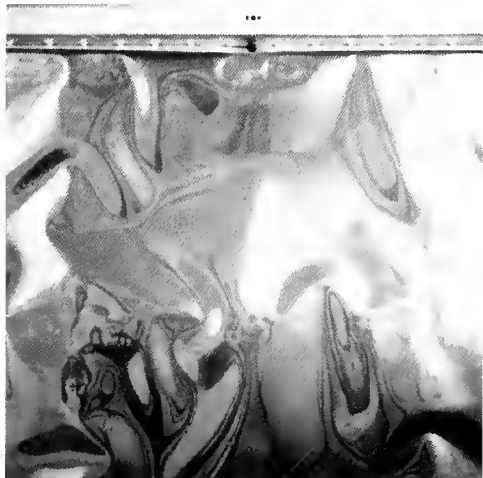
Figure 398 (Postflight). This photograph is of the upper center one-sixth of the tray. The thermal cover appears specular with no apparent damage. The reflective properties of the uneven surface of the cover result in various light and color patterns. The locations of the Velcro attachment pads are visible.

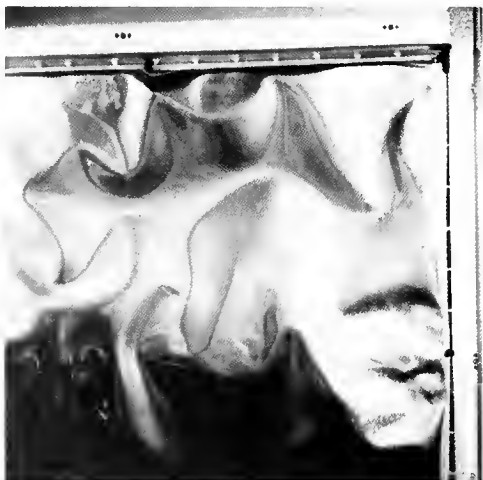
Figure 399 (Postflight). This photograph is of the upper right one-sixth of the tray. The grainy pattern in the surface finish, which is visible in the light reflection, was on the material prior to flight. The thermal cover appears specular with no apparent damage. The reflective properties of the uneven surface of the cover result in various light and color patterns. The locations of the Velcro attachment pads are visible.
